Manhole Inspection Summary

Manhole # S31CC2007MH

Location Address: **104 CHURCHWARDENS RD** Cross Street: **SAINT ALBANS WAY**

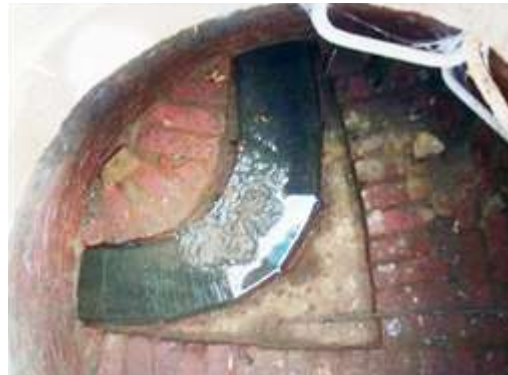
Top View

Corroded steps. Evidence of surcharge - Bench debris. Channel debris.

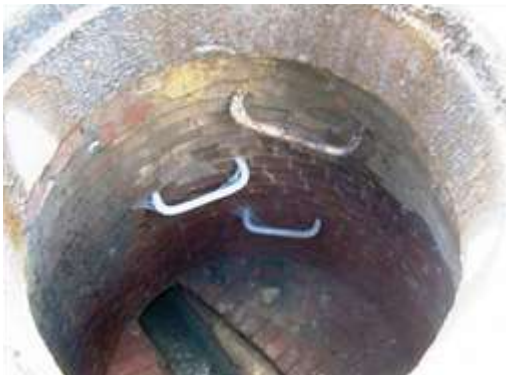
Defect

Frame leaks. Adjustment, Corbel and Barrel infiltration - other side.

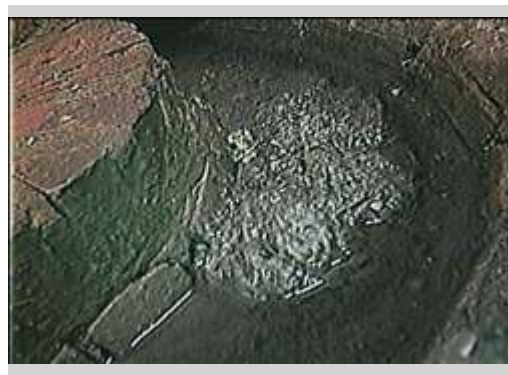
Defect

Channel deterioration and debris.

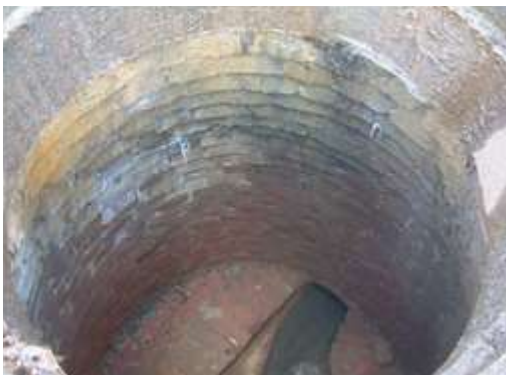
Defect

Frame leaks. Adjustment, Corbel and Barrel infiltration.

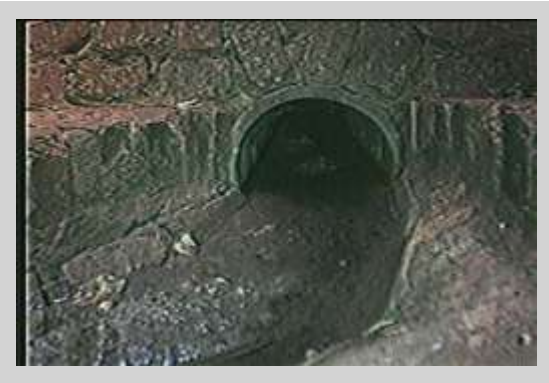
8 in. Circular Gravity Sewer Pipe Out @ 12 O'Clock

Barrel deterioration and infiltration. Channel deterioration.

Deposits: ☐ None ☒ **Mud** ☐ Sludge ☒ **Debris** ☐ Grease

Infiltration: **Evidence** Pipe Seal Cond: **Unknown**

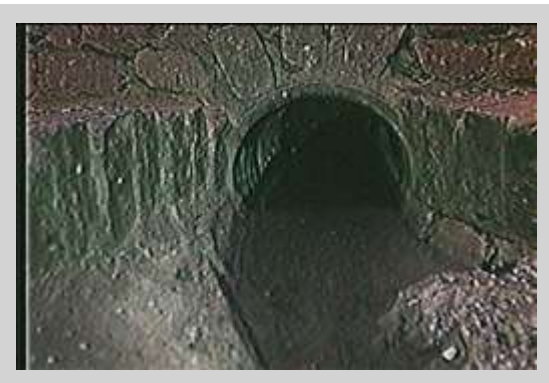
8 in. Circular Gravity Sewer Pipe In @ 9 O'Clock

Barrel deterioration and infiltration. Channel deterioration.

Deposits: ☐ None ☒ **Mud** ☐ Sludge ☒ **Debris** ☐ Grease

Infiltration: **Evidence** Pipe Seal Cond: **Unknown**
